Manhole Inspection Summary

Manhole # S45KK_054MH

Insp Date: **3/1/10 1:01 PM**

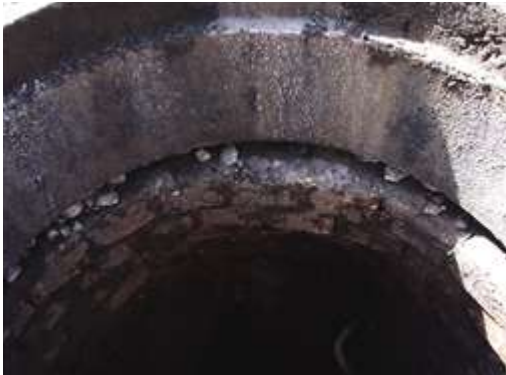
Defect 3

frame leaks

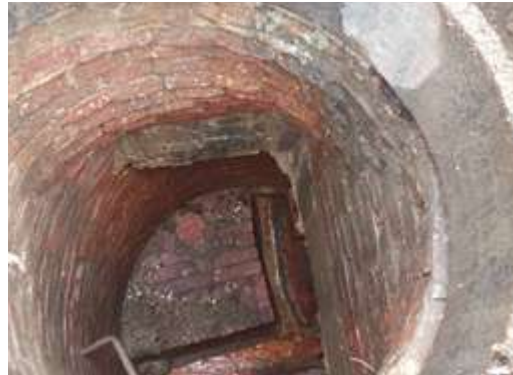
Defect 2

frame leaks

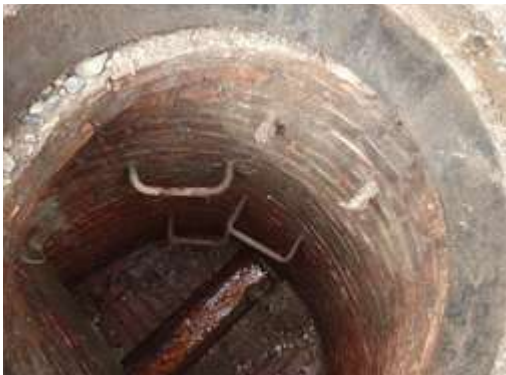
Defect 1

adjustment joint

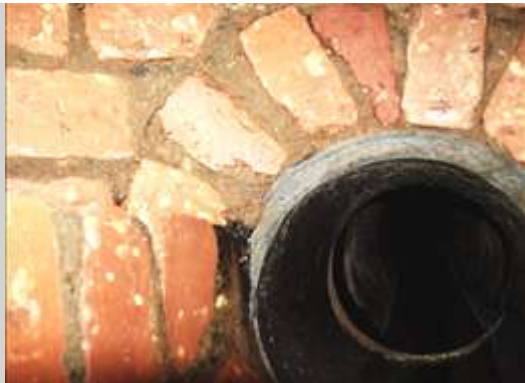
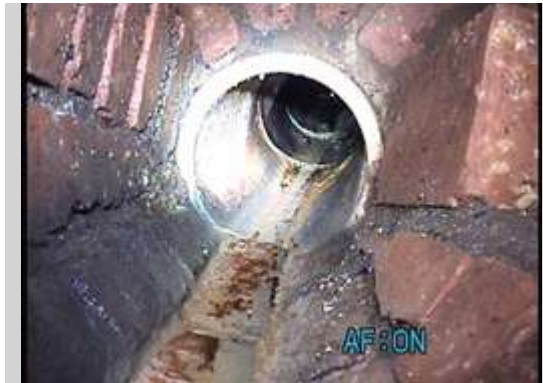
8 in. Circular Gravity Sewer

Infiltration: **None** Pipe Seal Cond: **Cracked**
